Technical Bulletin

Radio, Premium Sound System (Panasonic) "NO SAT" Displayed

91 06 11 Nov. 6, 2006, 2013208, Supersedes Technical Bulletin Group 91 number 06-07 dated October 20, 2006 due to updated Service content.

Model(s)	Year	Eng. Code	Trans. Code	VIN Range From	VIN Range To
Jetta	2005 - 2007	All	All	All	All
Rabbit, new GTI	2006 - 2007	All	All	All	All
Passat, Passat Wagon	2006 - 2007	All	All	All	All
Eos	2007	All	All	All	All

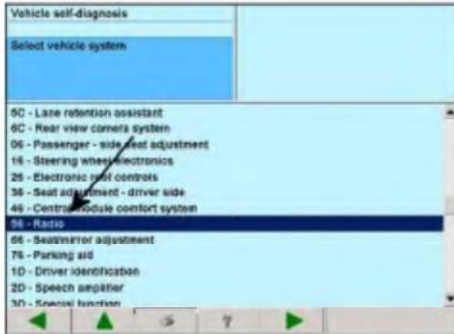
3. Access Address Word "56 -Radio", -arrow-.

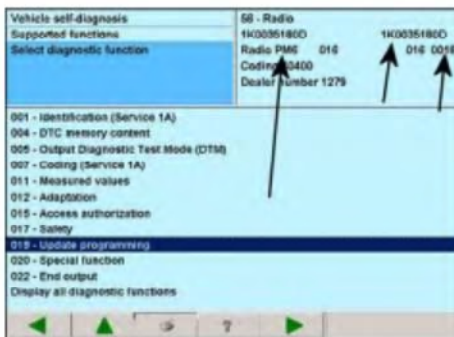
4. Look at header information which appears at the top of VAS screen. Panasonic Premium radios can be identified by either PM6 or ZSW letters, -arrows-.

Part number and software levels that apply are:

- 1K0035180C; 0018
- 1K0035180D; 0018
- 1K0035180G; 0019
- 1K0035180H; 0019.

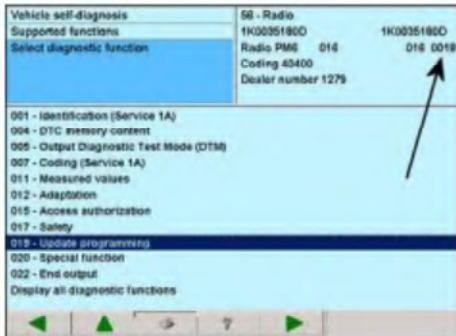
5. Is software level lower than 0021 and greater than 0018, -arrow-?

- Yes, press Go To button to Exit VAS tester. Turn ignition to OFF position. Go to step 1 in Programming Procedure for Panasonic Premium Radio.
- No, Radio software has already been updated, further diagnosis is required.

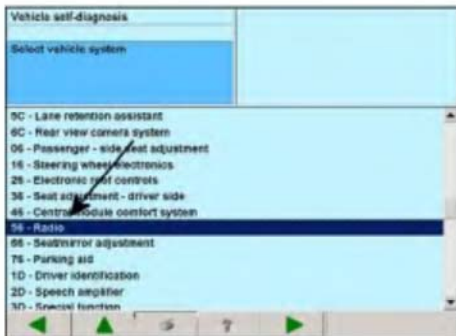
5. Access Address Word "56 - Radio", -arrow-.

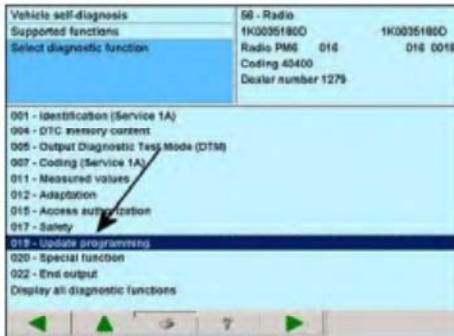
6. At the bottom of the screen, select “Update-Programming”, -arrow-.

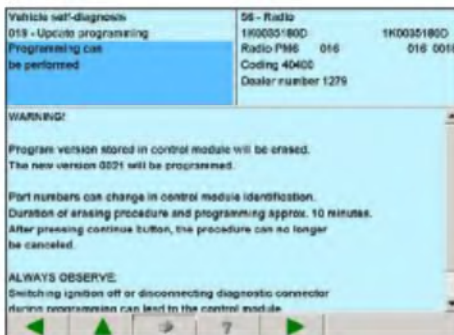
7. Read Warning displayed on screen, and go forward to next screen, the software programming process will begin, as shown.

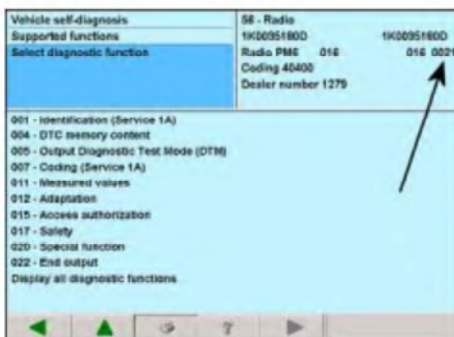
9. Once programming process has completed (100% on bar-graph), the VAS tester will display “Programming Log – Save Results?”

This screen displays old and new radio information. Software level in header of screen should now be 0021, -arrow-.

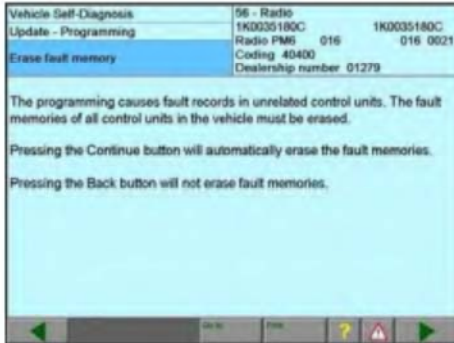
10. VAS tester will now prompt to "Erase Fault Memory?", as shown.

- DO NOT press forward button on VAS tester.
Instead, press the Go To button and select the option to Exit the VAS tester.

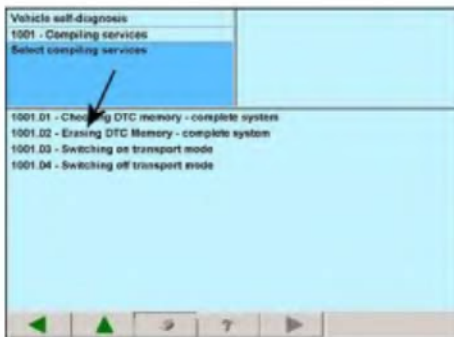
13. Select "1001.02 - Erasing DTC memory - complete system", -arrow-.
