# Technical Bulletin

Transmission Cooler, Fluid Seeping

37 06 03 Nov. 9, 2006 2010455 Supersedes T.B. Group 37 number 05-03, dated November 2, 2005 due to removal from Required Vehicle Update (RVU) status.

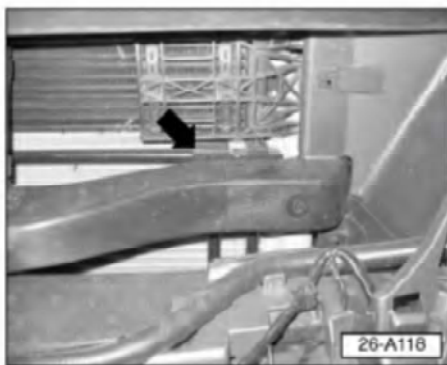
O-rings on the H-block may be misaligned on installation.

- Remove radiator grille from vehicle, see Repair Manual Group 66 Radiator Grille, Radiator grille, removing and installing.

If vehicle is equipped with Park Assist, disconnect the wire connections before removing grille.

Locate the transmission cooler lines and H-block assembly, located towards the drivers side of the vehicle.
