Technical Bulletin

Model(s)	Year	Eng. Code	Trans. Code	VIN Range From	VIN Range To
Passat, Passat Wagon	2006 > 2007	All	All	All	All

70 07 04 Feb. 19, 2007, 2013575

Rear Door Trim Panel Rattle

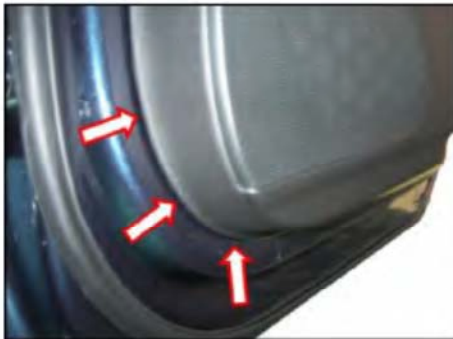
Insufficient tension of the attachment between door trim and inner door panel -arrows-.

Application of felt strips on the inner door panel.
