Technical Bulletin

Model(s)	Year	Eng. Code	Trans. Code	VIN Range From	VIN Range To
Passat, Passat Wagon	2006 - 2009	All	All	All	All

40 07 01 Apr. 02, 2007 2014645

Front Suspension, Knocking Noise

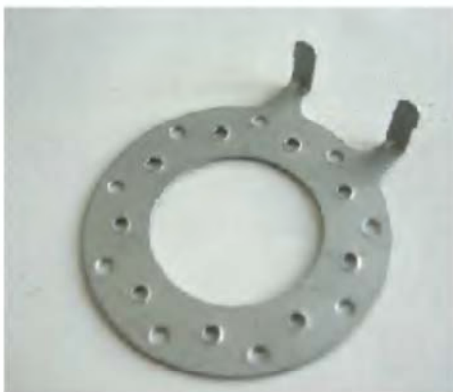
Knocking noise from vehicle front. Typically occurs only one time after each direction change (forward or backward, left or right), predominately on vehicle with V6 engines.

The subframe shifts slightly relative to the body due to wax residue in-between components. Maximum acceleration and braking in vehicle's that are driven hard are contributors to the occurrence.

Install two speciality plates (washers) Part No.: 7M3499349A following the procedure below.
