Technical Bulletin

94 07 01 April 24, 2007 2014428

Parking Indicator, Sounds Off with No Obstacle

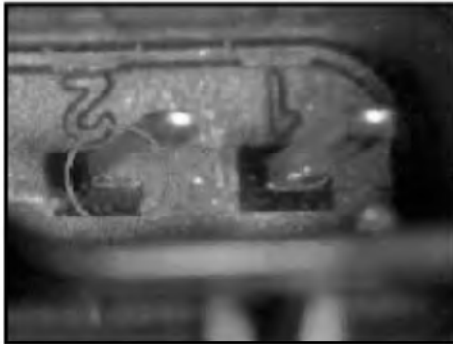
Water intrusion into sensor holders causing corroded plug contacts and sensor electrical pins resulting in acoustic feed back in the attachment area of sensor(s)

- Switch Ignition OFF and place key on seat.
- Remove front grille and front bumper cover, see Repair Manual Group 63 Bumper in ElsaWeb.
- Disconnect parking aid sensors by gently separating parking aid sensor retaining tabs and sliding sensor out of retainer.

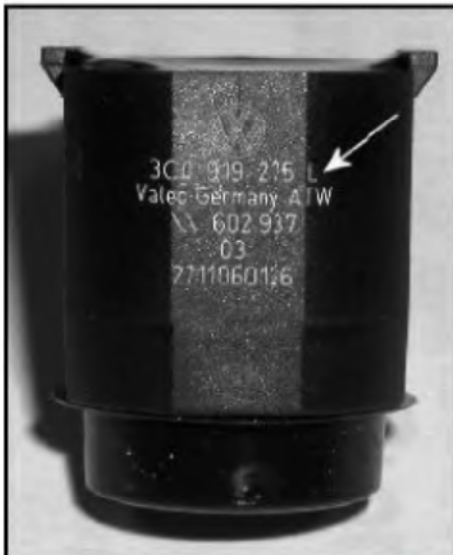
- Inspect sensor terminals and wiring harness connector terminals of all sensors (front and rear) for corrosion, clean as necessary.

If corrosion is too severe:

- Replace sensor, wiring harness connector and terminals.
