# Technical Bulletin

24 07 10 Oct. 10, 2007 2013155 Supersedes T. B. Group 24 number 06-01 dated Nov. 8, 2006 due to VIN correction and update to warranty table.

Malfunction Indicator Lamp (MIL) Illuminated, DTCs P0171, P2187 Stored in ECM Memory

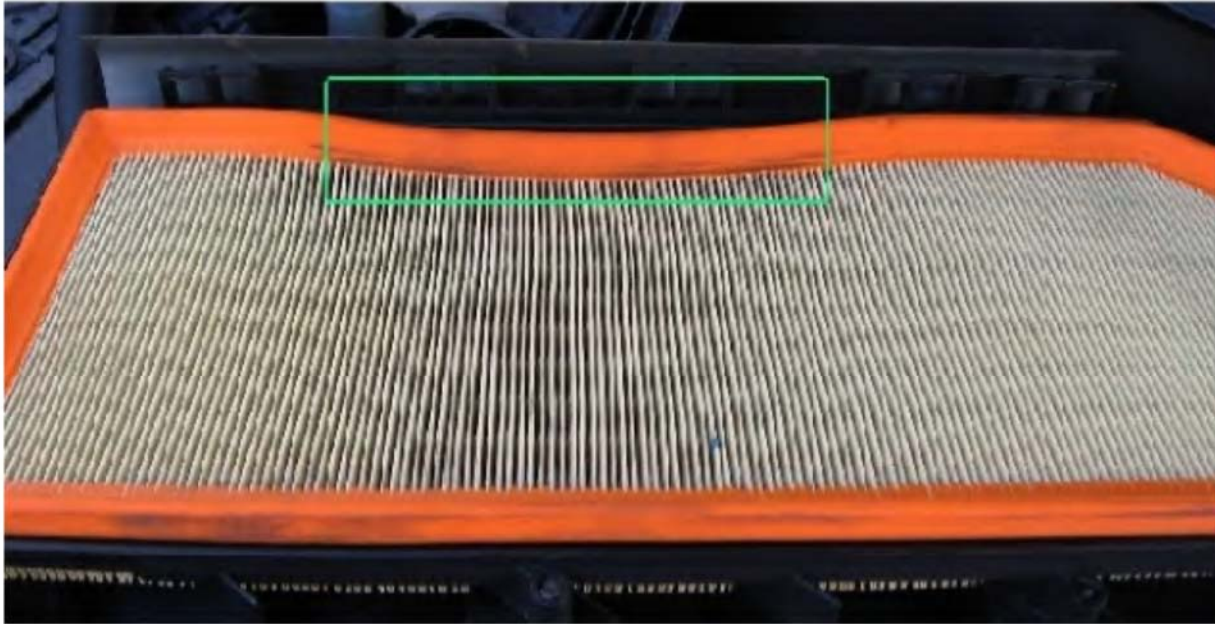
The condition may be the result of the incorrect positioning of the air filter element (see illustration) due to the deformation of the back side of the lower air filter housing. The change in the air flow distribution inside the air filter housing results in an inaccurate output signal from the mass air flow sensor -G70-.

If the air filter element cannot be correctly positioned because the lower air filter housing is deformed:

- Replace the air filter housing, see Repair Manual Group 24 Mixture preparation system, electronic inj., Gas in ElsaWeb.
