Technical Bulletin

46 07 05 Oct. 12, 2007 2015173 Supersedes T. B. Group 46 number 07-03 dated July 6, 2007 due to brake disc run out specification change.

Brake Disc, Pulsation

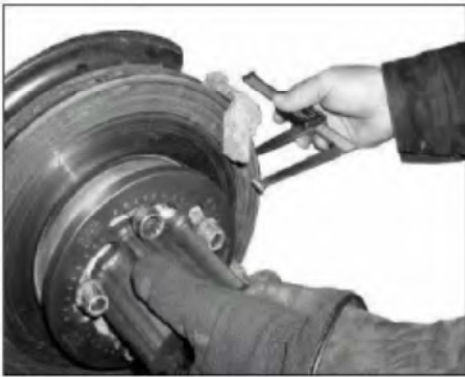
- Inspect brake disc friction surfaces on both sides of the brake disc for:
 - Severe discoloration (bluing)
 - High heat surface damage (raised hard spots)
 - Visible cracks

Brake discs showing any of the above described conditions **MUST** be replaced.

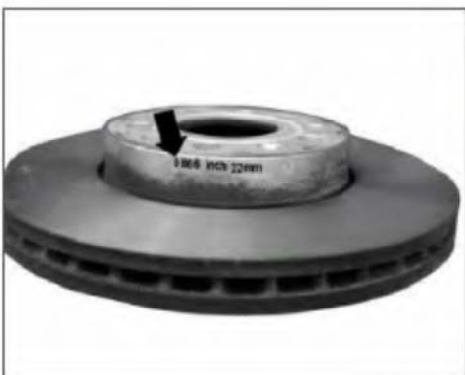
- Measure the brake disc thickness in 4 locations using either the Pro Cut International™ disc thickness measuring tool Part No. 50-902 or the Hunter Engineering Company disc thickness measuring tool Part No. 25-99-2 . Measurements **MUST** be taken the same distance from the brake disc outer circumference to ensure consistency.

The brake disc must exceed the minimum thickness after the machining process is completed in order to be reused.

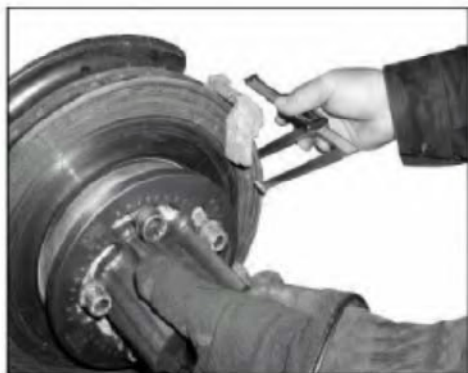
- Re-measure brake disc thickness in 4 locations using either the Pro Cut disc thickness measuring tool Part No. 50-902 or the Hunter disc thickness measuring tool Part No. 25-99-2, to verify that minimum thickness is still exceeded. If recorded brake disc measurement is less than the minimum thickness, the brake disc MUST be replaced.

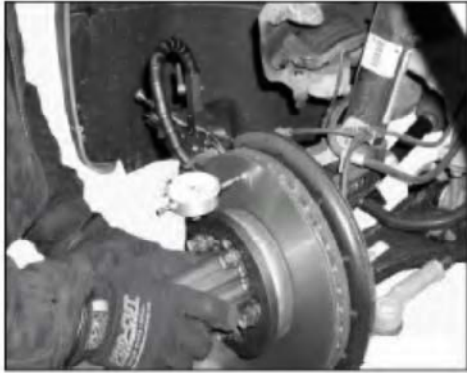
- Measure brake disc lateral run out using Pro Cut Disc Lateral run out measuring kit Part No. 50-700FC or the Hunter Disc Lateral run out measuring kit Part No. 25-128-2 with a dial indicator.
- Run out must not exceed 0.1mm.
