Technical Bulletin

Model(s)	Year	Eng. Code	Trans. Code	VIN Range From	VIN Range To
Passat, Passat Wagon	2006 - 2007	2.0L (BPY)	All	All	All
GTI	2006 - 2007	2.0L (BPY)	All	All	All
Jetta (A5)	2005 - 2007	2.0L (BPY)	All	All	All
Eos	2006 - 2007	2.0L (BPY)	All	All	All

15 07 05 Nov. 14, 2007 2015153, Supersedes Technical Bulletin Group 15 number 07-04 dated June 29, 2007 due to fuel pump replacement clarification.

MIL ON, DTC P0087, P1093 or P2293 Stored in ECM Fault Memory

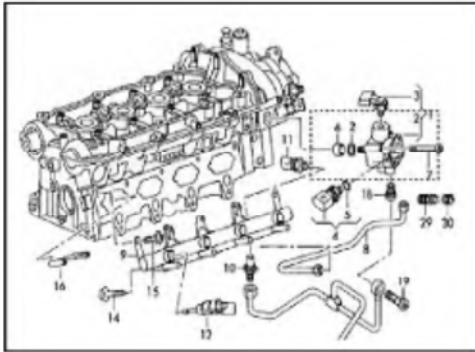
Remove the high pressure fuel pump and visually inspect:

1. Base surface of the cam follower -6- in contact with the camshaft lobe.
2. Tip of the high pressure fuel pump plunger.
3. High pressure fuel pump camshaft lobe.

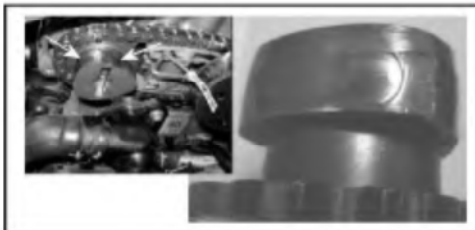
Excessive wear of intake camshaft lobe that drives the high pressure fuel pump. The wear limits maximum pump piston lift, causing fuel rail pressure fluctuations.

The wear on the camshaft lobe can also lead to wear on the base of the high pressure fuel pump cam follower.

If the base of the cam shaft follower looks like -C- or -D-, no excessive wear is present.

If the cam follower base surface is excessively worn so that its surface is concave -B- or missing -A-, inspect the intake cam shaft lobe for wear.

Cam follower and camshaft should NOT be replaced.

If the high pressure fuel pump camshaft lobe shows excessive wear, replace the intake camshaft with Part No. 06F109101B and the cam follower with Part No. 06D109309C, see Group 15 Engine - Cylinder head, Valvetrain in ElsaWeb.

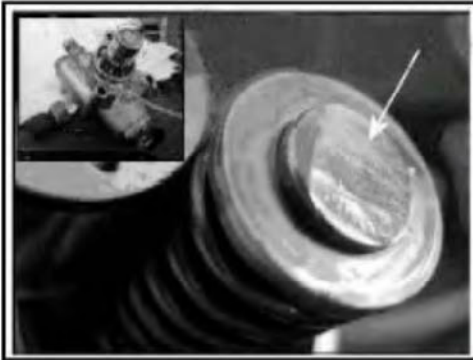
Inspect the tip of the high pressure fuel pump plunger for excessive wear.

High pressure fuel pump plunger damage is only possible if the cam follower base has a hole in it and the plunger tip has come in direct contact with the camshaft lobe.

If plunger tip of fuel pump is **NOT WORN**, **DO NOT REPLACE** the fuel pump.

If excessive wear is found the high pressure pump must also be replaced, see Group 20 Fuel Supply in ElsaWeb.
