Technical Bulletin

Model(s)	Year	Eng. Code	Trans. Code	VIN Range From	VIN Range To
Passat Sedan	2006 - 2008	All	All	All	All

68 08 01 Mar. 13, 2008 2017463

Sunshade, Back Glass, Damaged or Will Not Operate Properly

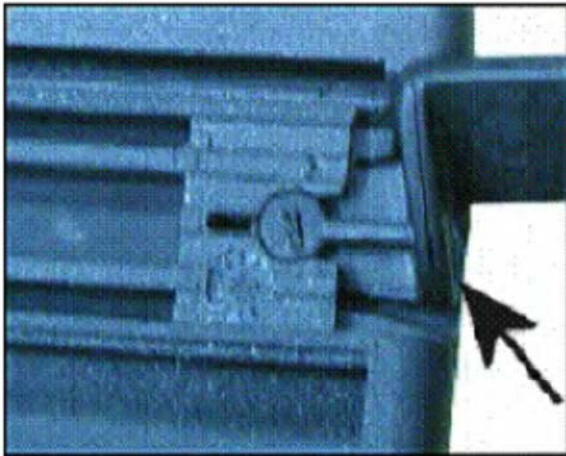
Figure 1

One or both sunshade friction pads may be broken causing sunshade to track outside retaining rails. Sunshade handle may also be broken due to increased effort.

- Using a flat blade screw driver, lift damaged or broken friction pad(s) up and away, see figure 1.
-
