# Technical Bulletin

64 08 01 Mar. 18, 2008 2010637 Supersedes T.B. Group 64 number 06-09 dated September 21, 2006 due to updated model years.

Heated Rear Window, One or More Lines Are Inoperative

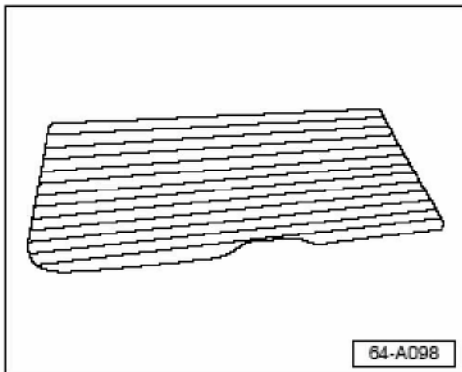
One or more lines of the heated rear window -Z1- (rear window defogger) are inoperative.

May be caused by small gaps in the individual lines of the heating element.

Heated rear window, identifying gaps

Detect which line is inoperative by touching your hand to each line.

- Working lines will be warm to the touch.
- Damaged line(s) will not generate heat.

- Switch ignition and heated rear window OFF.
- Visually locate gap (open circuit)
- Mark this location with tape and continue to check other lines as necessary.

With gap(s) in line(s) identified, repair as follows:

Heated Rear Window line, repairing using Repair kit by Permatex®, ITEM 09117 (obtain locally)
