# Technical Bulletin

Model(s)	Year	Eng. Code	Trans. Code	VIN Range From	VIN Range To
Passat, Passat Wagon	2006 - 2008	All	All	All	All

91 08 03 Mar. 26, 2008 2017501

Radio Cuts Out While Driving

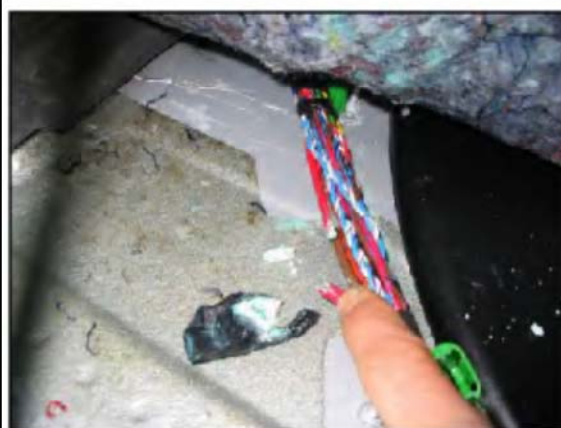
Figure 2

Power supply splice B219, located under the driver's seat and routed to radio amplifier, may have corrosion due to excessive water saturating carpet and entering splice.

- Remove driver seat, see Repair Manual Group 72 Seat Frames, in ElsaWeb.
- Remove driver sill panel, see Repair Manual Group 68 Interior Equipment, in ElsaWeb.
- Pull back carpet to expose wire harness, see Figure 1.
- Verify corrosion in wire splice similar to, or as shown in Figure 2.
- Repair splice using Wiring Harness Repair Kit Part No. VAS 1978 A, see Repair Manual Group 97, Wiring, in ElsaWeb.
