Technical Bulletin

87 07 14 Sept. 26, 2007 2005566 Supersedes T. B. Group 87 number 07-07 dated May 10, 2007 due to update warranty information.

HVAC, Musty Odor

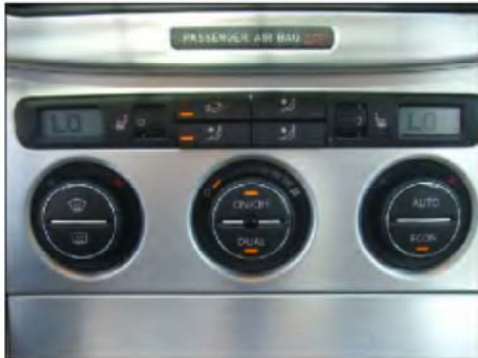
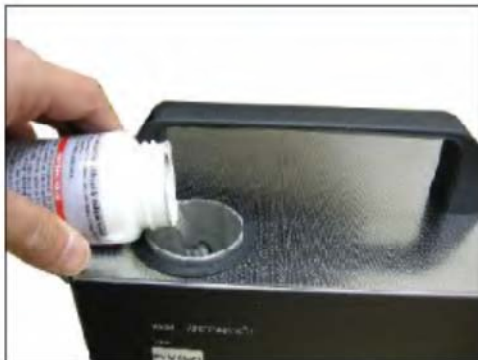
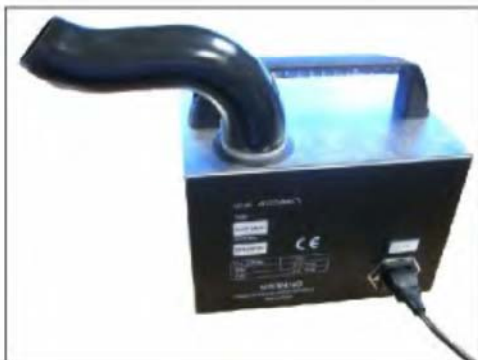
- Start engine.
 - Set climate control temperature to its lowest setting.
 - Set fan speed to its lowest setting.
 - Set airflow direction to dash vents only.
 - Activate recirculation and ECON modes.
-
- Thoroughly shake a 100ml bottle of treatment and empty bottle into filling chamber.
-
- Connect outlet tube.

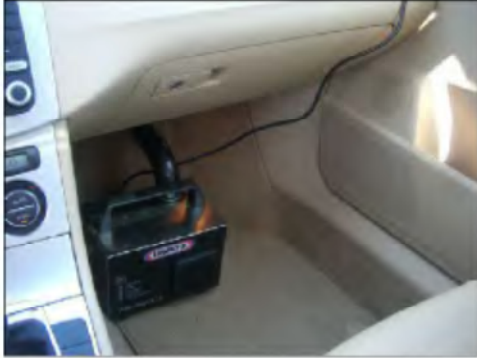
- Place cleaning unit into passenger foot well, make certain that the unit is as level as possible.
- Connect power cord and route it through a slightly opened window. The remaining windows and sunroof should be completely closed.
- Switch unit on and position outlet tube such that vapor is drawn into recirculation air intake, generally in passenger foot well area.

Refer to appropriate repair information for exact location.

- Close all doors.

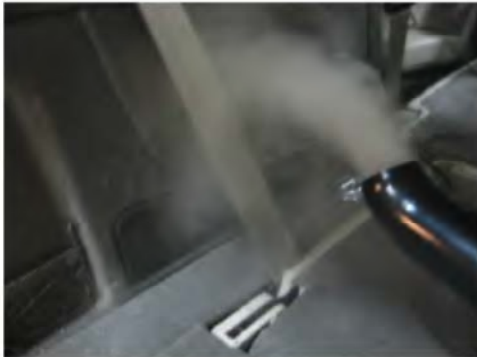
The atomized cleaning fluid will begin coming out of vents. After about 15-20 minutes treatment stops automatically.

If vehicle is a Touareg or Phaeton with 4 zone climate control, rear A/C unit is to be treated as well. Repeat procedure for rear A/C unit.

Use same A/C settings as was used for front A/C unit. Position outlet tube toward vent on left of rear compartment.

- Air out vehicle after procedure for about 10 minutes.
