Technical Bulletin

69 08 02 Feb. 11, 2008 2011271, Supersedes Technical Bulletin Group 69 number 07-03, dated Mar. 23, 2007 due to Labor Operation code update.

Igniter, Side Airbag, Diagnostic Trouble Code(s) Stored in DTC Memory

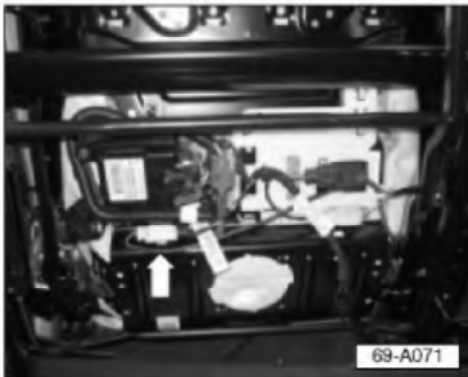
Rabbit/ new GTI / Eos ONLY:

The pictures are used to illustrate connector location only, seat does not have to be disassembled for repair.

- Remove male and female side connectors T3K (N199-drivers side), T3L (N200 passenger side, as shown) by cutting one wire at a time, discard connectors.
