Technical Bulletin

Model(s)	Year	Eng. Code	Trans. Code	VIN Range From	VIN Range To
Passat, Passat Wagon	2007	All	All	3C_7E143905 3C_7P068990	3C_7E999999 3C_7P999999
Rabbit, GTI	2007	All	All	1K_7W061194	1K_7W999999
Touareg	2007	All	All	7L_7D057930	7L_7D999999

92 08 01 Apr. 10, 2008 2017605

Rain Sensor Damaged during Removal

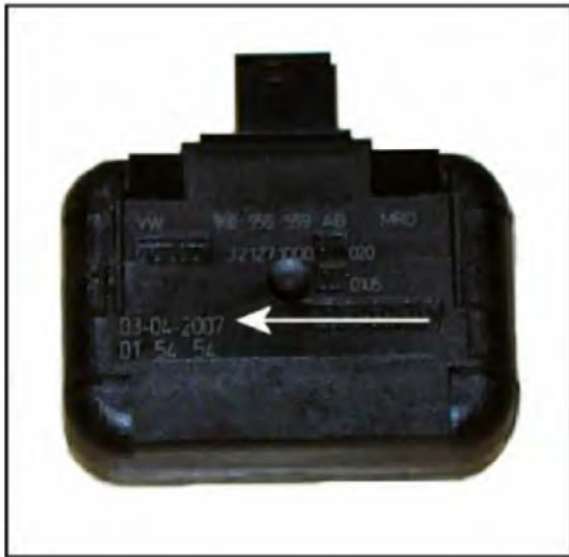
Date on rain sensor 03-04-2007 (white arrow).

In addition to claim comment per warranty table, enter production date of sensor in SAGA 2 comments box.
