Technical Bulletin

94 07 01 April 24, 2007 2014428

Parking Indicator, Sounds Off with No Obstacle

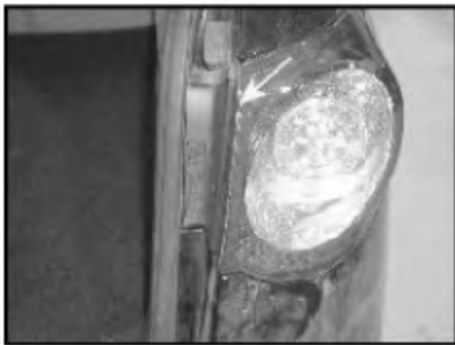
Rear Tail Lamp Removal, Wagon Only

Care must be taken when removing rear tail lamp assemblies from the wagon. Failure to do so will result in damage to tail lamp assembly and spring clamps.

• Carefully remove snap in reflector next to tail lamp assembly using removal wedge VAS 3409 and remove tail lamp fastener.

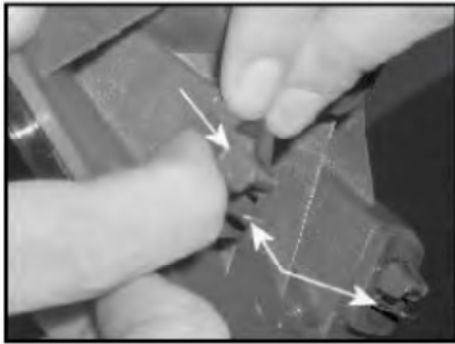
The tail lamp housing is retained to the rear fender by spring clips -lower arrows-. The tail lamp housing can be easily damaged, causing tail lamp replacement, if removed improperly.

There are grooves molded into the lamp housing -upper arrow- that fit into the rear fender. The spring clips -lower arrows- provide the necessary tension to retain the tail lamp housing.
