# Technical Bulletin

Electrically Folding Side View Mirror, Whistling Noise

66 06 04 Oct. 20, 2006 2013172

Model(s)	Year	Eng. Code	Trans. Code	VIN Range From	VIN Range To
Passat, Passat Wagon	2007	All	All	All	All

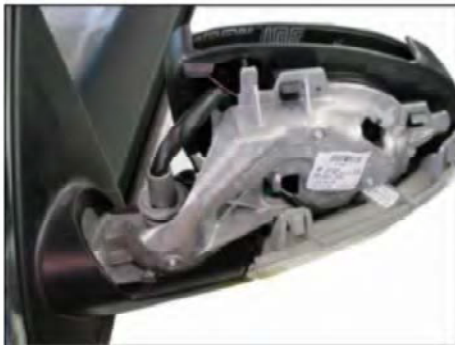
A wiring harness may interfere with the proper installation of the mirror cover to the mirror housing, possibly leaving a small gap.

While driving, air can enter the gap causing a whistling noise.

Applying an adhesive backed bumper Part No: ZVW269008 will prevent the wire harness from interfering with the proper installation of the mirror housing cover.
