Technical Bulletin

Model(s)	Year	Eng. Code	Trans. Code	VIN Range From	VIN Range To
Passat (B6)	2006	BLV (3.6L)	All	All	3C_6E186616 3C_6P154906

Catalytic Converter, Replacement, Rear Oxygen Sensors Not Required

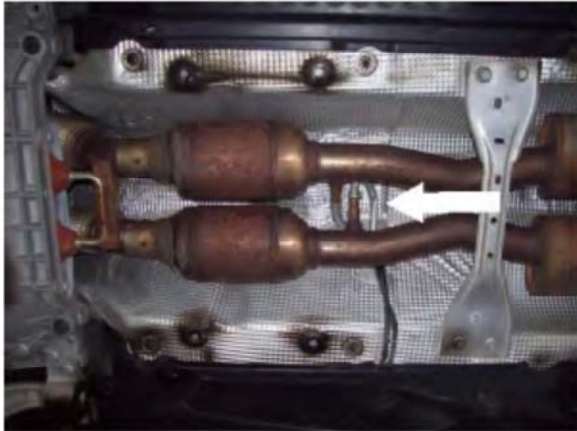
Early build MY06 Passat were produced with three oxygen sensors per catalytic converter. Only four oxygen sensors (two per converter) are used for OBD. Rear oxygen sensors -arrow- are not monitored by the ECM. When replacing catalytic converter(s), the unused body harness connector(s) must be weather sealed for harness protection.

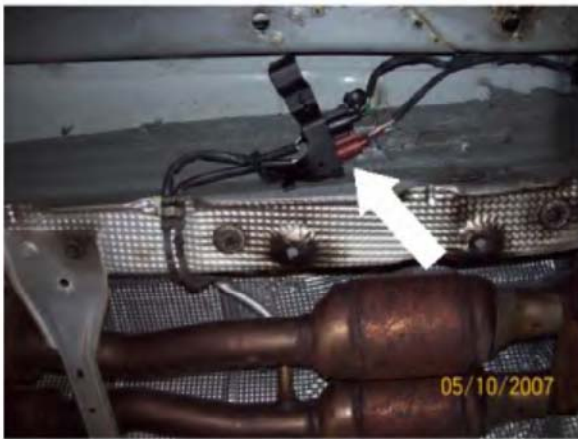
Locate rear oxygen sensor connectors -arrow-

This repair requires that the rear oxygen sensor connectors be removed from the oxygen sensors prior to catalytic converter disposal. The connectors will be modified to act as "covers" and "fasteners" for the body harness connectors.
