Technical Bulletin

Model(s)	Year	Eng. Code	Trans. Code	VIN Range From	VIN Range To
Passat, Passat Wagon	2006 - 2008	All	All	All	All

80 07 08 Nov. 28, 2007 2016869

Heater, Output Perceived as Insufficient, Climatronic System Only

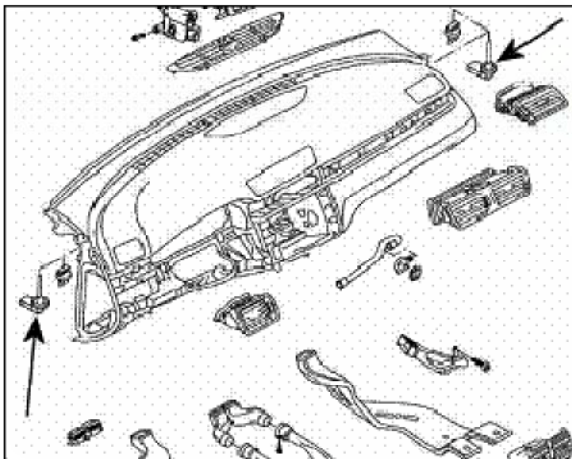
Diagnose the -G150- and/or -G151- temperature sensor (arrows) using normal GFF protocol.

-G150- sensor is located behind driver's side instrument panel cover, in the vent tube (next to the fuse panel), -G151- sensor is located on passenger side in the vent tube.
